**03 Crank assembly**

### **03 Pistons**

### 03 Connecting rods, pistons

## 03 Crankshaft radial sealing ring

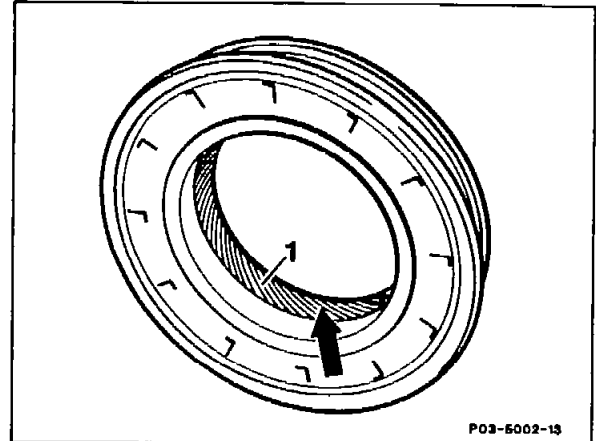
If oil leakages occur at the front of the crankshaft, it is only necessary in the most frequent cases to replace the crankshaft radial sealing ring. Replacing hub at the same time is only necessary in those cases where two wear tracks (grooves) are visible on the hub. For hubs which have only one wear track (groove) a radial seal with a sealing lip offset 2 mm to the rear is available (repair version). If the sealing surface of the hub is only ground bright, only the standard version of radial seal may be fitted.

Press the radial seal dry (without grease) into the timing case cover and coat the sealing lip (Fig., item 1) with engine oil – do not use grease.
