05 Hydraulic valve clearance compensating elements

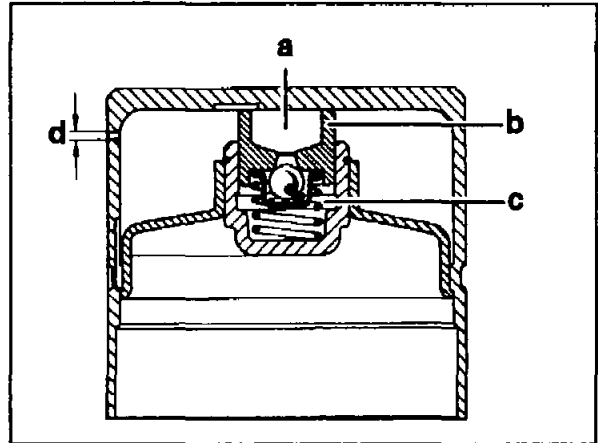
P05-0175-13

Some of the oil can run out of the hydraulic elements when the engine is started and shut off frequently or after it has remained shut off for a longer period, e.g. over night, resulting in noises for a short time after starting.

These compensating elements have a reduced residual stroke, i.e. the piston stroke (9) and the working chamber (c) have been reduced increasing the size of the reservoir chamber (a). Less oil is required in the working chamber due to the reduced stroke. For this reason the working chamber refills more quickly when the engine is started.

Install modified bucket tappets, part no. 601 050 05 25.

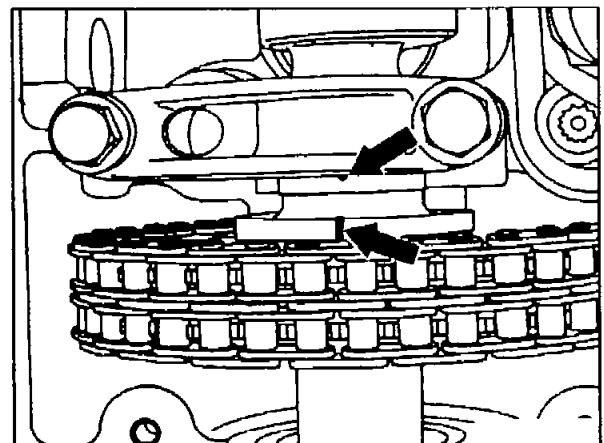
P05-2206-13

Engine problems as a result of stretched timing chain.

1. Slowly rotate the crankshaft in direction of rotation of engine until the markings of the camshaft and bearing bracket are aligned.
2. Read off the difference in degrees crank angle ($^{\circ}$ CA) at the crankshaft belt pulley. For engine 604/605/606 see AR 05.20-6010 HA).
 - a) If difference is 3° to 10° CA, the timing chain should be replaced.
Engine 601/602/603 (RA 05.10-320)
Engine 604/605/606 (AR 05.10-7601 HA)

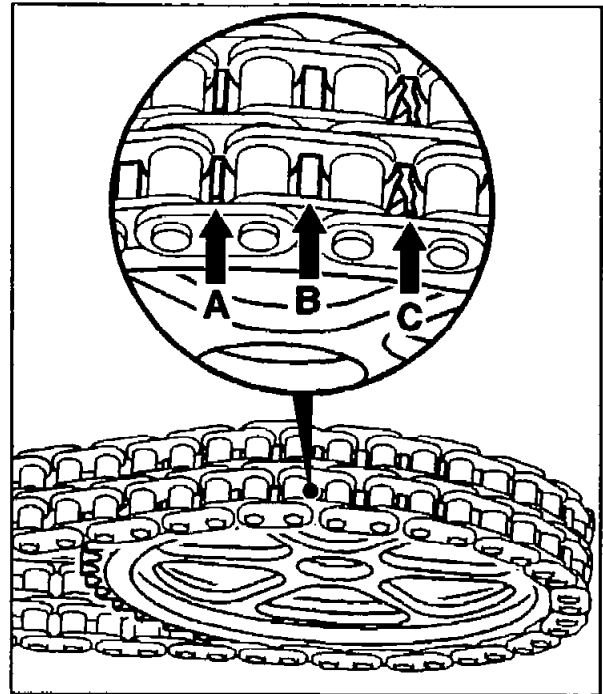
P05-5498-15

b) Inspect all the teeth of the camshaft sprocket for signs of wear. Crank the engine twice at the crankshaft for this purpose. Specified condition arrow B. If teeth tips are broken off (arrow C), or wear at tooth flanks (arrow A), replace camshaft sprocket and timing device.

Engine 601/602/603 (RA 07.1.1011-240)

Engine 605/606 (AR 07.12-8014 H)

On engine 604 replace camshaft sprocket and drive gear of distributor-type injection pump.
