46 Steering

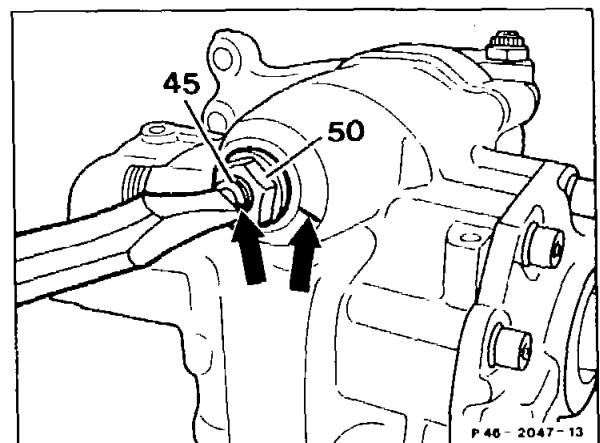
46–89021 Oil flows out at steering gear adjusting screw Models
124, 201

Polyamide ring on lock nut does not provide adequate seal.

Replace lock nut, part No. 001 990 70 51

- a) To do this, remove steering gear on cars with gasoline engines (46–3400).
Remove air filter housing complete on cars with diesel engines.
- b) Mark position of adjusting screw with notches (arrows).
- c) Replace lock nut without altering position of adjusting screw.
Tighten lock nut to 65 Nm.

If the adjusting screw has been inadvertently turned, re-set friction value of steering gear (46–0120).

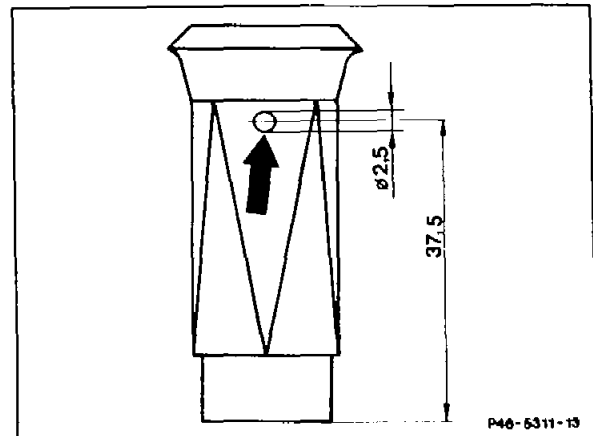
46-88051 Oil flows out through breather cap of power steering pump

Reservoir incorrectly filled (too high),
see (46-0715).

No breather in protective tube.

Correct the oil level.

Drill breather (arrow) according to sizes
indicated.
