Engine speed characteristics

The specific engine speed characteristics are described below in order to facilitate fault diagnosis.

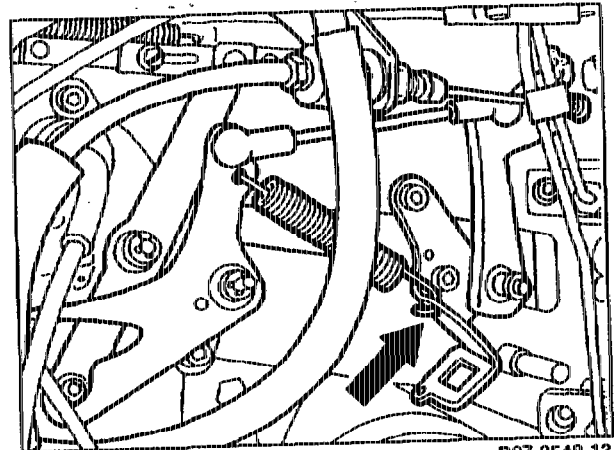
P07-2549-13

Idling occasionally > 1100 rpm (engine at operating temperature)

1. Return spring wrongly attached at fulcrum lever.
2. Throttle valve idle speed contact (S29/2) is not operated.

1. Attach return spring correctly at fulcrum lever (see Fig.)
2. Test idle speed contact at throttle valve switch (see Diagnosis Manual Engine, Volume 2, Index 2).

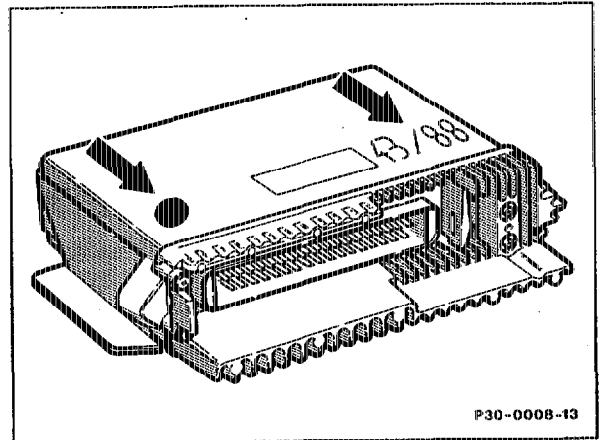
ASR indicator lamp lights up when driving and electronic accelerator pedal moves into emergency running mode (difficult to depress after short idle travel)

1. Check production date of control unit
(see Fig.)
Control units with production dates from 16/88 up to 43/88 must be replaced with a control unit as of production date 44/88 (identification: yellow dot) if this fault occurs.
2. Check throttle control linkage, adjust
(see 30-1010, Section "B").
3. Replace potentiometer (R25).
