Programmed Repairs Engines 602.96, 603.96/97 Combustion

07.1 Diesel Injection System

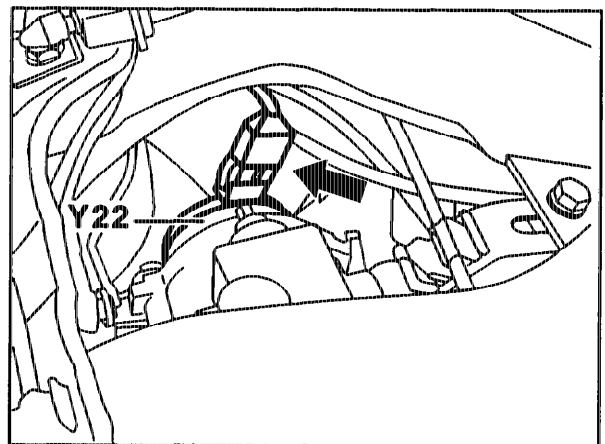
P07-6354-13

Engine surges when idling

Engine 603.96 w/o AJC

Unplug 2-pin connector (arrow) at servomagnet (Y22).

If engine runs properly, check idle speed and set, if necessary, to 580 ± 20 rpm.

Install modified control module part no. 006 545 36 32 and plug in 2-pin connector again.

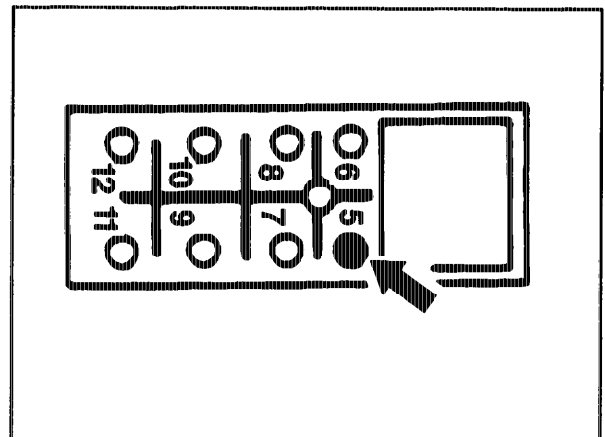
P07-6357-13

Coding bridge of old control module must not be plugged into the new control module.

When inserting the new control module, pierce the non-assigned contact 5 in the connector (arrow).

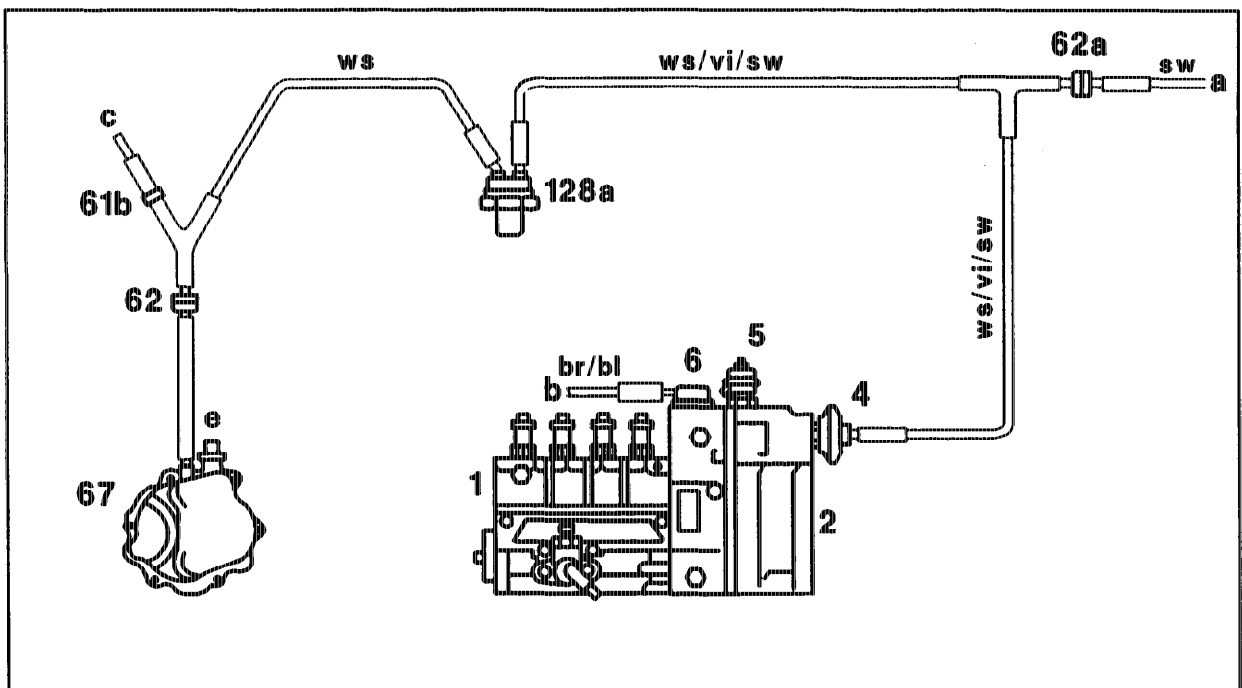
P07-6356-55

Engine cannot be switched off or not easily.

- Vacuum hose and vacuum pump (67) may be split.
- Filter (62) blocked or leaking.
- Restrictor (61b, orange) may be blocked.
- Vacuum of vacuum pump not sufficient. Check vacuum at ancillaries connection. Specification when engine idling after 30 s at least 700 mbar.

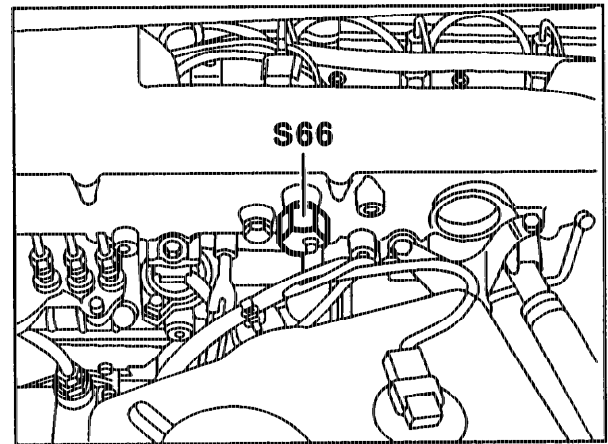
P07-6355-13

Engine misfires at full load from 2000 rpm

Boost pressure too high or engine overload protection activated too soon.

Test boost pressure with connector unplugged from engine overload protection switch (S66).

If boost pressure > 0.95 bar, boost pressure control valve of turbocharger faulty. Replace turbocharger.

If boost pressure < 0.95 bar, switch engine overload protection (S66) reacting too soon. Replace switch (S66).

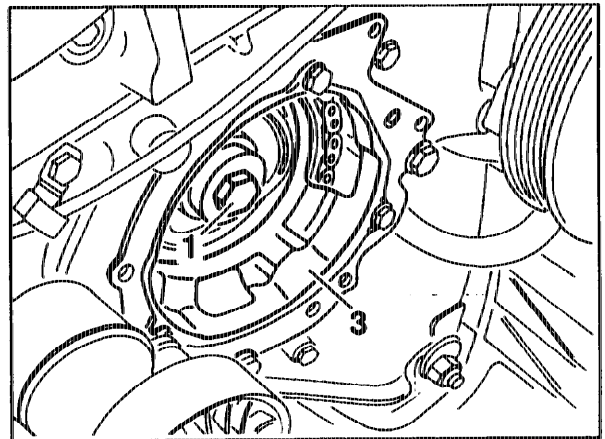
P43-2001-13

Engine cannot be switched off when cold (was SI 07.1/37 and 43/6)

Damaged piston vacuum pump (model up to May 1986).

If this problem exists on models manufactured prior to this date, which do not have a second drilling in the oil spray nozzle for the oil supply of the piston vacuum pump, or for performing work which requires taking off the vacuum pump, remove the centering sleeve and install in modified seal for improving the oil supply.

- 1 Remove flange shroud, fan and belt (see Repair Instructions Group 13, Op. No. 342).
- 2 Remove piston vacuum pump (see Repair Instructions Group 43, Op. No. 618).
- 3 Remove centering sleeve (3). It must no longer be installed.

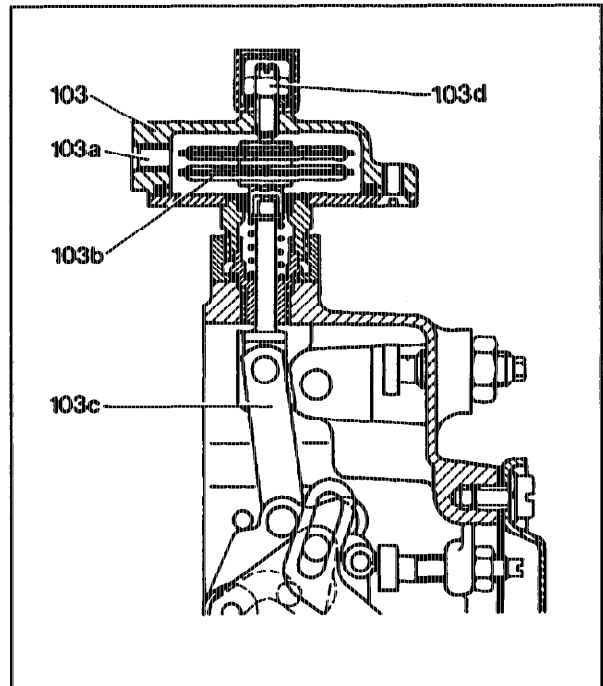
P07.11-0003-02

Sluggish acceleration when engine cold up to about 2000 rpm

- a) Full load stop not correctly set.
- b) Insufficient full load quantity.

- a) Check setting of accelerator control linkage, adjust (see RA30-1010).
- b)
 - 1 Remove boost air pipe, install (see RA14-1310).
 - 2 Set full load quantity at barometric pressure compensation unit:
 - Take off cap (black) on barometric pressure compensation unit (103).
 - Slacken lock nut (103d).
 - Use a screwdriver to turn setting screw about 1/4 turn to the left.
 - Tighten lock nut (103d).
 - Fit on cap.

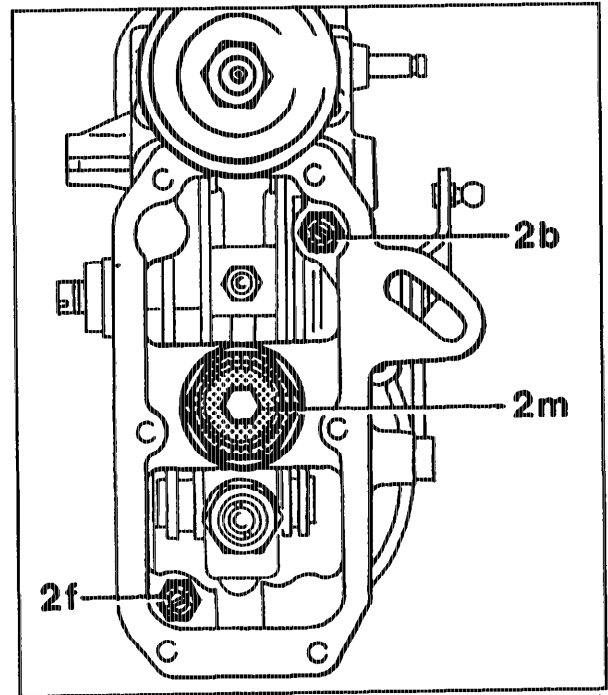
P07.11-0001-15

Poor engine output, sluggish acceleration, top speed is not reached.

a) **Engines without anti-jerk control (AJC):**

- Turn slotted screw (2f) about 1/4 turn to the left.
