15 Engine

54 Equipment, Instruments

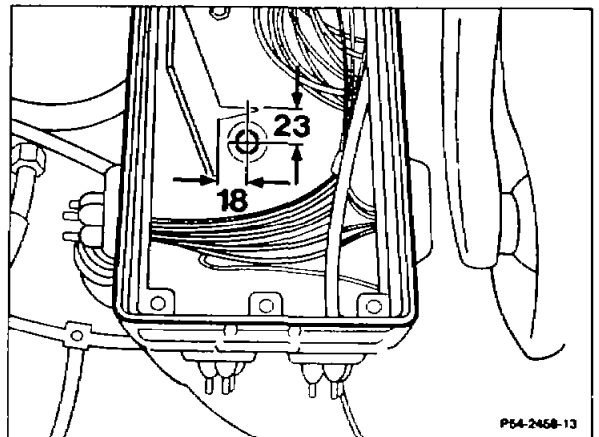
Molsture or water in fuse and relay box

Leak at the rubber grommets or at the cover of the fuse and relay box.

Remove fuse carrier and dry fuse box; replace any damaged parts.

Drill 6 mm dia. hole as shown in sketch.
Examine all rubber grommets and fuse box cover for leaks, seal if necessary with sealant or new rubber gasket.
