## 01-1300 Cleaning, sealing main oil galleries

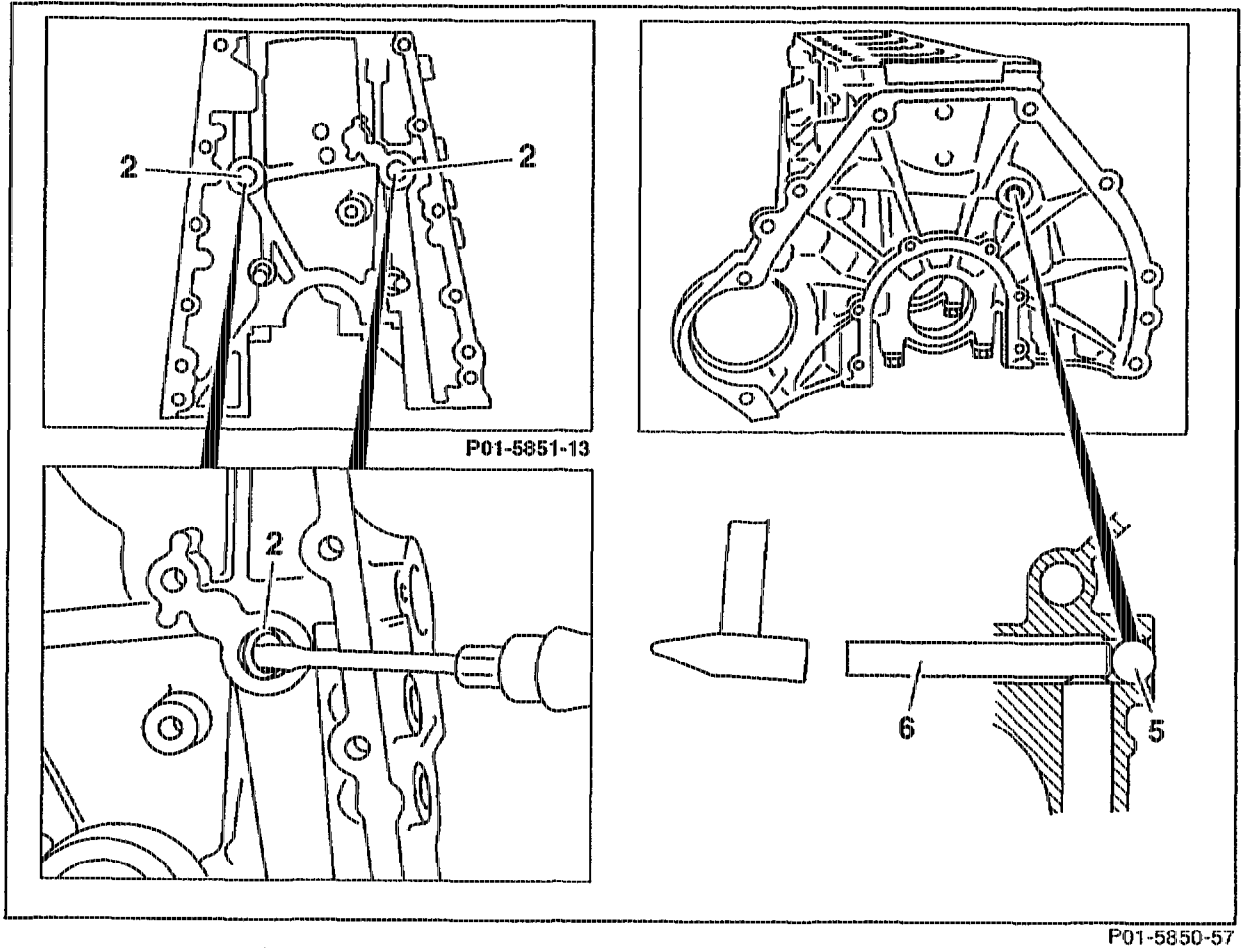
P01-5851-13

Front plug (2) .....	knock in on one side with the screwdriver, press out.
Rear steel ball (5) .....	knock out with round bar (6) (approx. 11 mm dia., length 750 mm)
Oil galleries .....	clean.
