01-2240 Checking rear of engine for leaks when running

Transmission 722.3

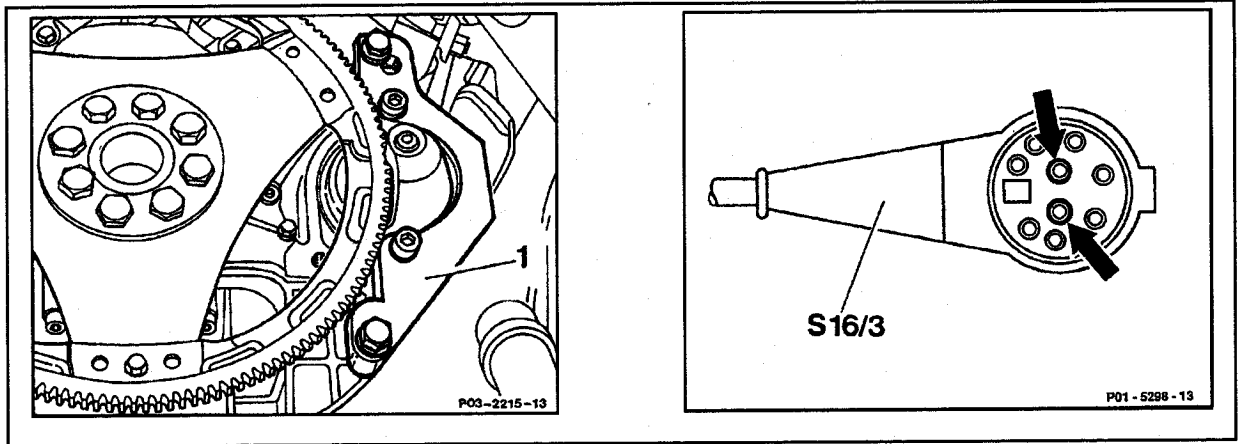
P01-5801-53

Rear of engine	clean.
Dried surrounding area	spray with Mercedes-Benz white contrast spray, part no. 000 989 03 59.
Oil level in engine	check, adjust to correct level (18-0020).
Driven plates with ring gear	install (03-4100).
Starter with bracket (1)	bolt to crankcase, special tool 119 589 00 40 00.
Engine in installation position	support at rear and secure.
Automatic transmission	bridge contact at starter lockout switch (S16/3) (arrows).
Engine	start, check for leaks.
