## 01-0200 Inspecting cylinders with light pobe, assessing cylinders

Operation no. of operation texts and work units or standard texts  
 and flat rates  
 01-1321

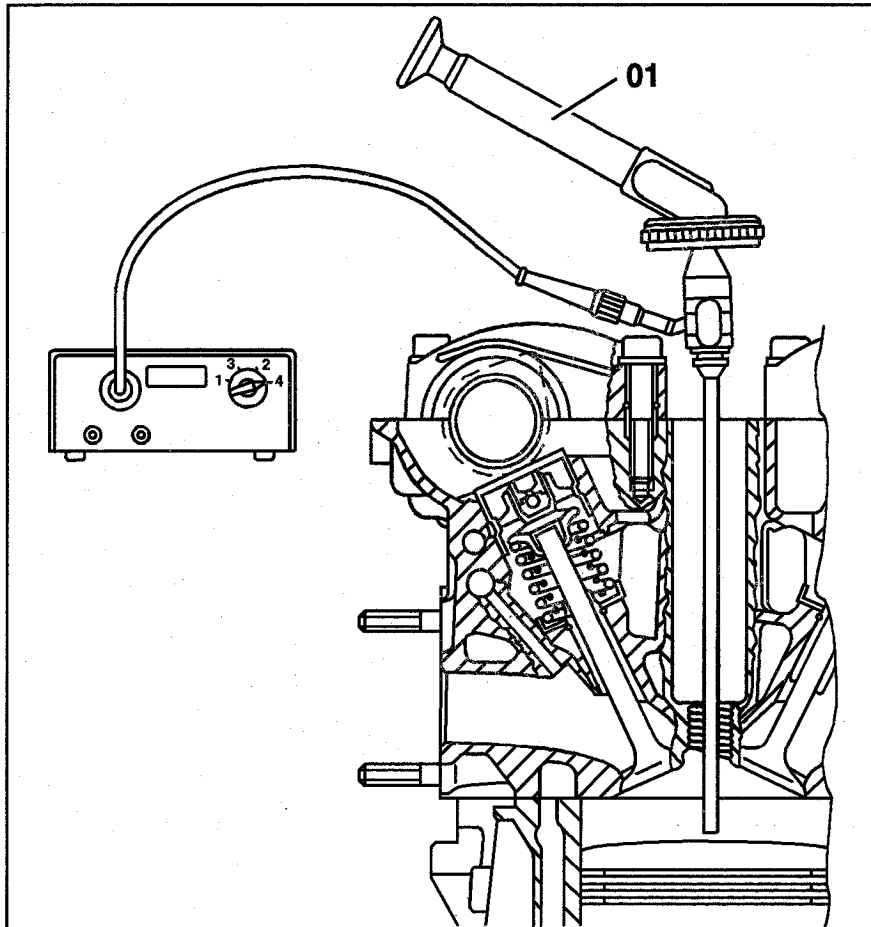
P01-6031-37

Piston .....	position to BDC, see table.
Motoskop and lens probe .....	connect. Motoskop TW 12 V to car battery Motoskop TW 220 V to mains.
Lens probe .....	insert into cylinder, remove.
Cylinder .....	inspect, assess, see note.

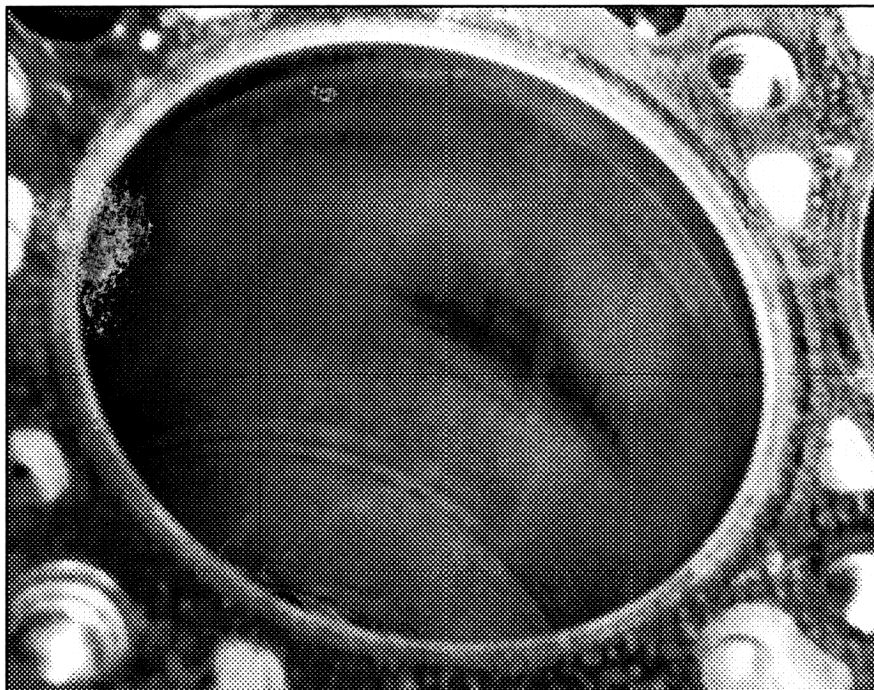
P01.40-0265-35

**2. Bright pressure marks, smoothing**

Individual bright points e.g. in the middle of the cylinder or in the area of the cylinder head bolt pipes.

Continue using crankcase.

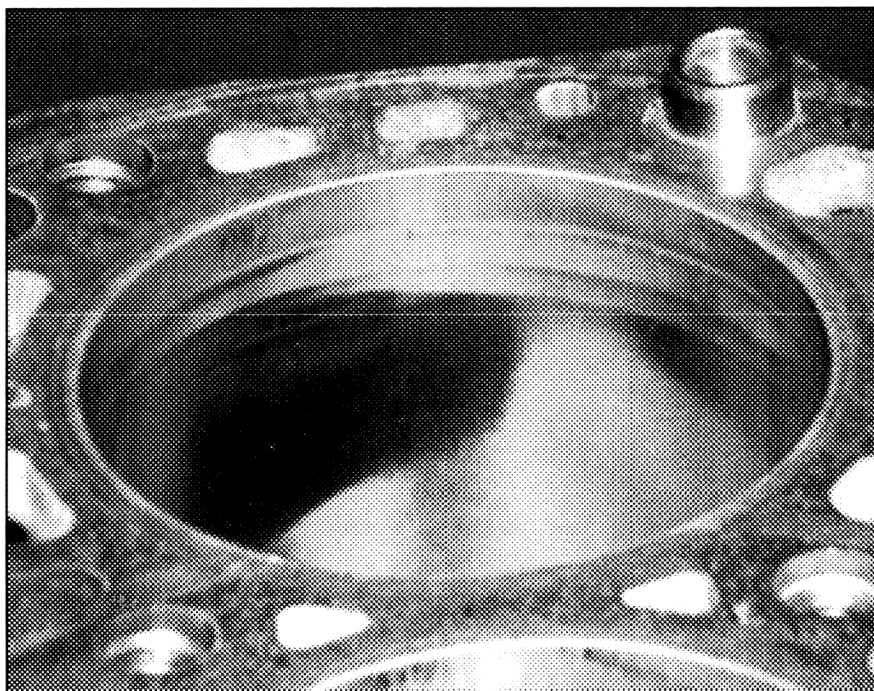
P01.40-0266-35

**3. Bright cylinder surfaces, polished and reflective all round**

Usually starting from the first piston ring, in the top area of cylinder, with measurable partial cylinder wear.

Cylinder wall un-serviceable.

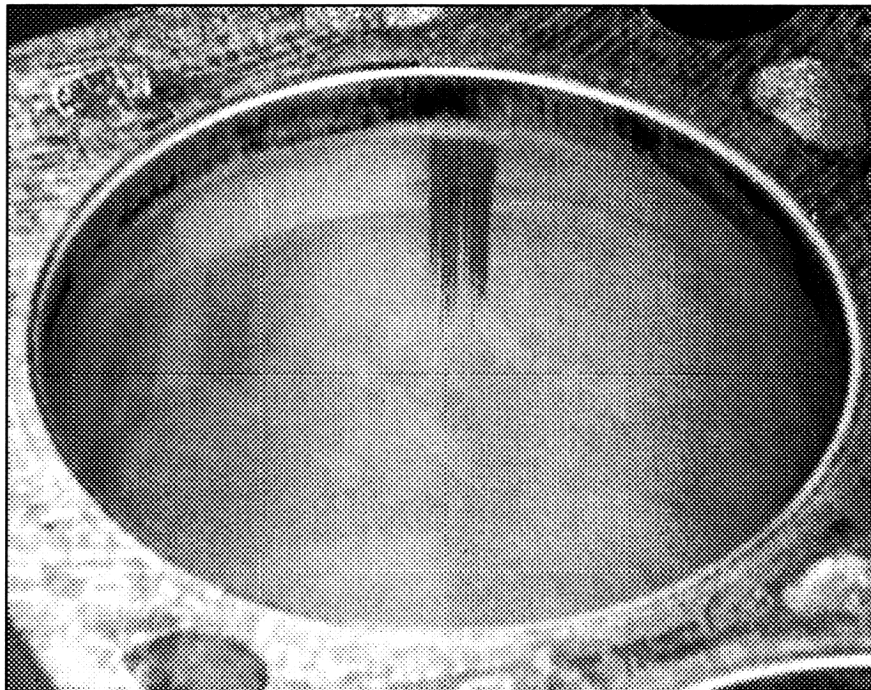
P01.40-0267-35

#### 4. Visual streaks, traces of rubbing

Starting from first piston ring, extending for about 30 mm. Traces of dry rubbing which cannot be felt, caused by fuel ablation of the oil film, e.g. frequent cold starting in short-distance driving. These traces of rubbing, which are likely to be found in the area of the cylinder head bolts and on the pressure side, are acceptable if smoothed. The piston rings are not damaged. Continue using crankcase.

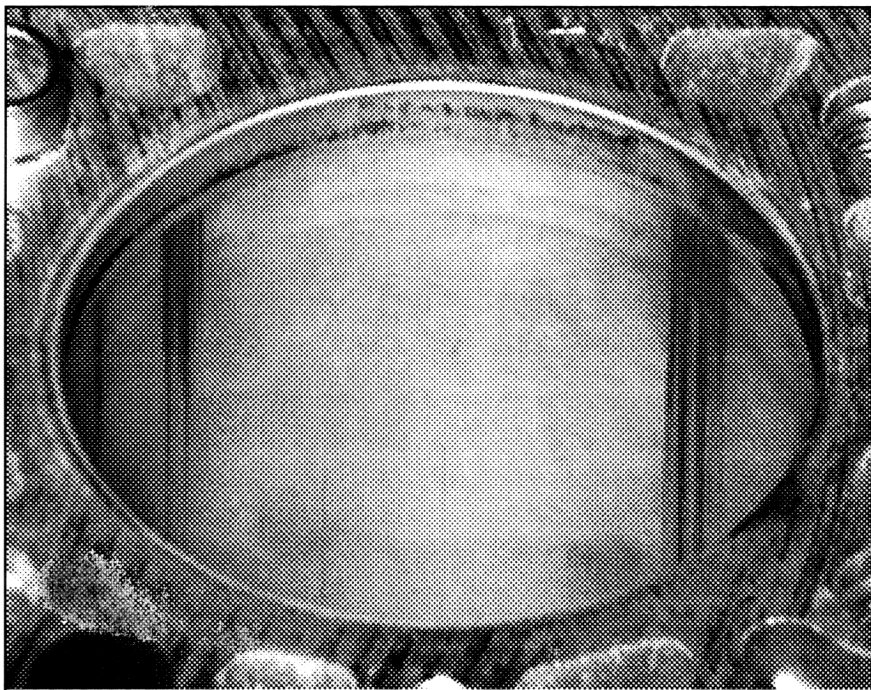
P01.40-0268-35

#### 5. Roughened streaks, traces of seizure

Starting from the first and second piston ring and extending initially to the bottom part of the cylinder. Traces of rubbing as described in section 4 have progressed to seizure. Piston rings may be damaged. If the streaks can be felt, cylinder wall unserviceable.

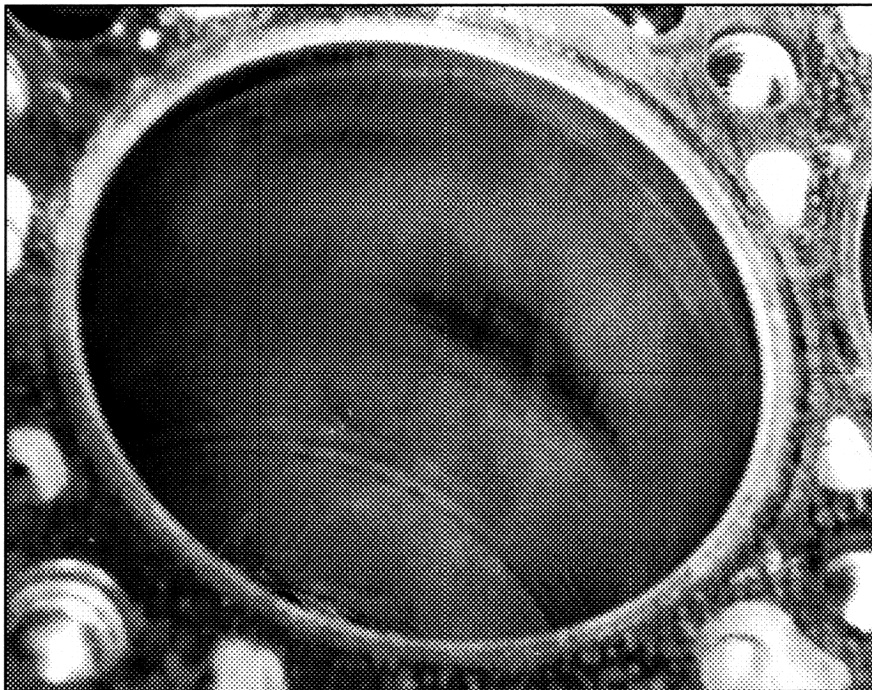
P01.40-0265-35

#### 6. **Ring-shaped impressions**

Visible in the top and bottom piston ring reversal area, are acceptable.  
Continue using crankcase.
