AR05.00-P-2011HY

Removing, installing hydraulic valve clearance compensation elements (bucket tappets)

ENGINE 604, 605, 606**3 Compensation element**

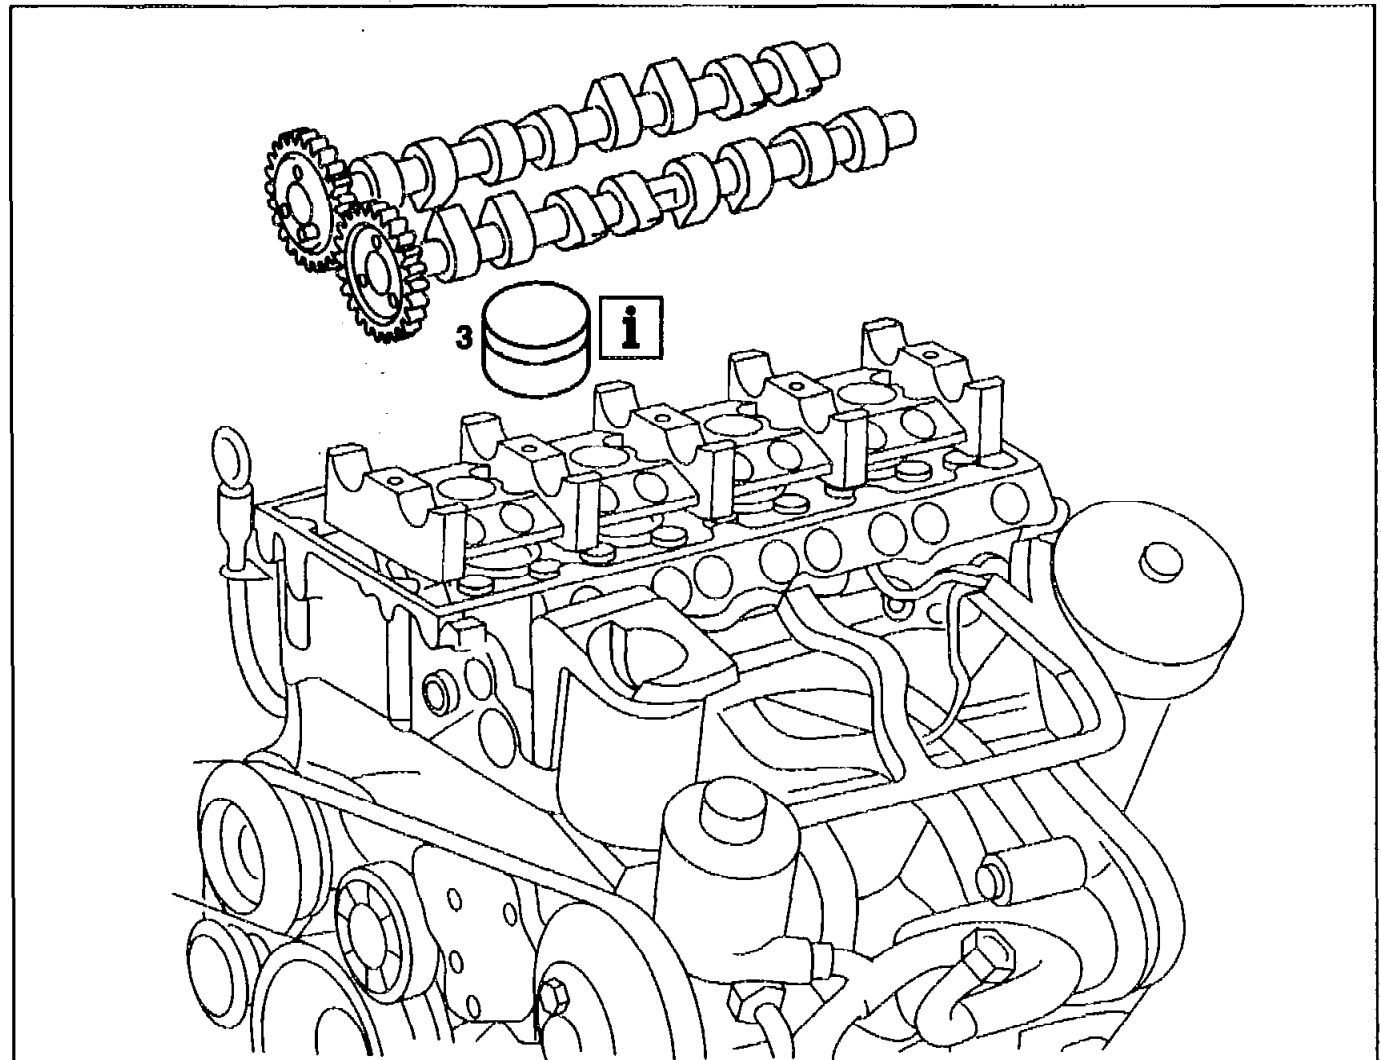
Fig. item, etc.	Work instructions		
	Camshafts	remove	AR05.20-P-6992HA N3
3	Compensation elements	<p>remove</p> <p>i Do not use a magnet!</p> <p>The sliding surface of the compensation element would otherwise be magnetized as a result of which minute iron swarf would gather and would cause damage to the compensation element and cam.</p> <p>Re-install compensation elements at the same point if not replaced.</p> <p>Inspect surface of basic bore for scores and damage,</p> <p>if necessary according to condition, replace camshaft housing.</p>	<p>WH58.30-Z-1008-02A</p> <p>AR05.20-P-6995HA F4</p>
