46-0715 Filling and bleeding the power steering pump/tandem pump

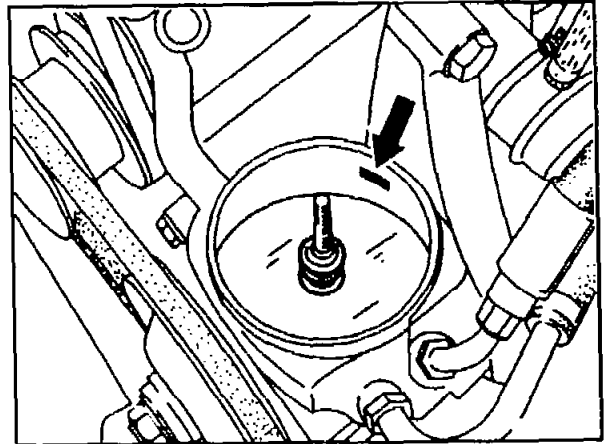
P46-5383-13

1. Version (model 201 up to 09/84)

When engine is cold (room temperature approx. 20°C) oil level 6–8 mm below marking (arrow).
When oil is at operating temperature (approx. 80°C) correct oil level up to the embossed or cast-in marking (arrow).

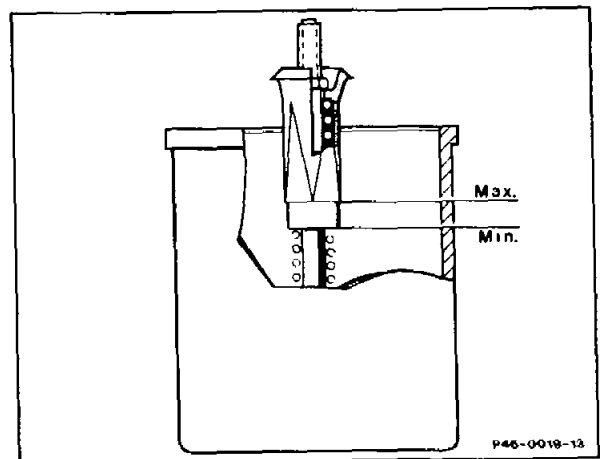
P46-0018-13

2. Version 10/84 to 01/91

The reservoir is filled correctly when the oil (20–50°C) is between the min. and max. markings, 28–36 mm below the edge of the reservoir.

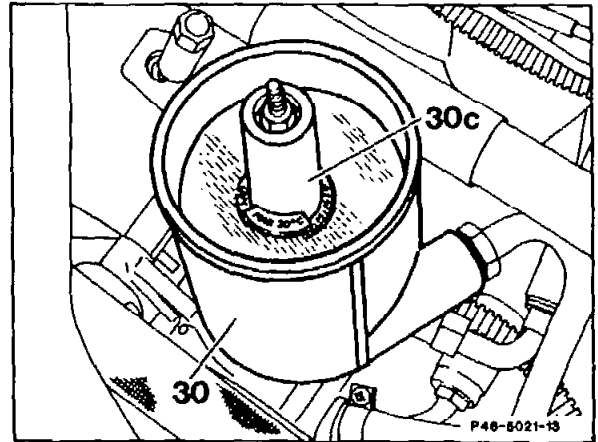
3. Version as of 02/91

When engine is cold (room temperature 20°C) oil level at the maximum marking of the oil level display (30c) of the power steering/tandem pump (30).

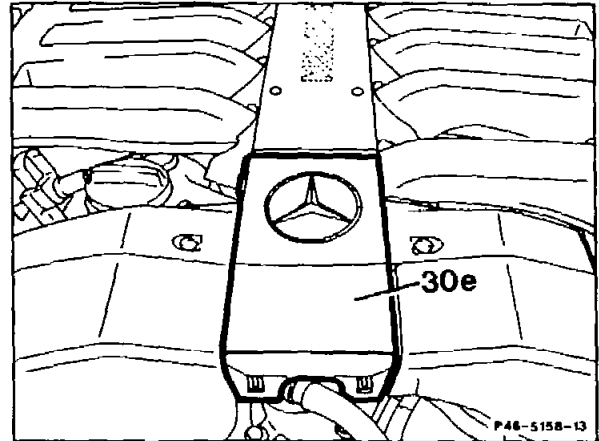
Engine 120

Remove plastic cover (30e).

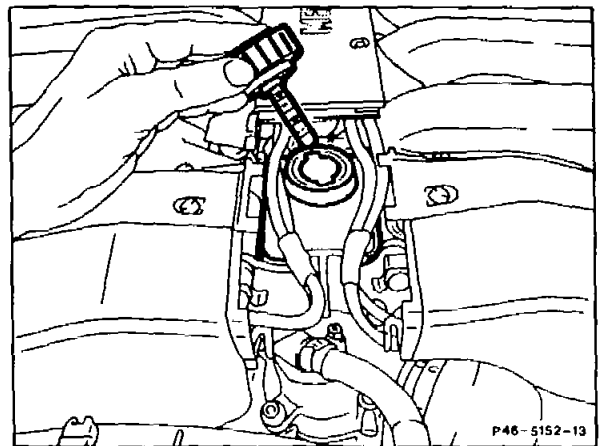
The oil dipstick with "min" and "max" marking for the oil level check is on the cap of the expansion reservoir.
