Update on Repair Procedure for Mono-Wiper Assembly

Mercedes-Benz W124 chassis pre-1994 by Anthony Tugwell

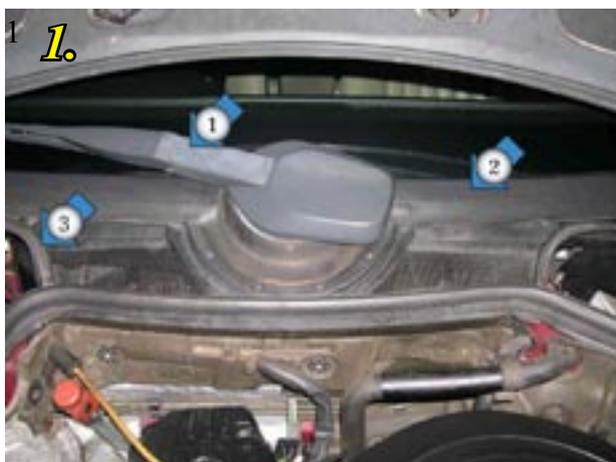
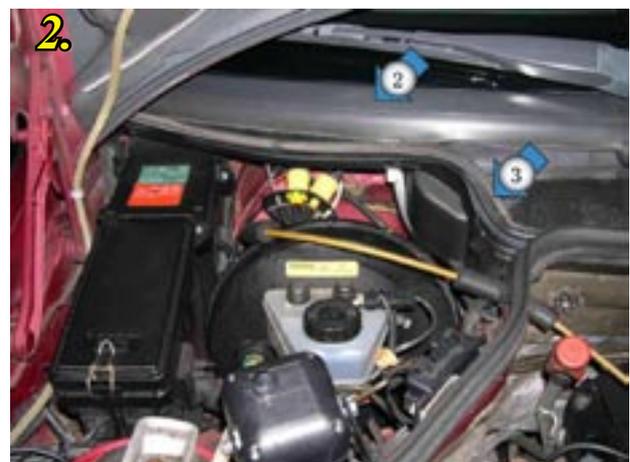
1. Remove the arm cover and hex screw from the wiper arm.
2. Remove the two rubber strips (AT - mouldings along the bottom edge of windscreen) from each side of the lower windshield by pulling them straight out. (*Fig 1*, *Fig 2*).

3. Pull off the rubber weather-stripping that runs right across the inner firewall area. (Fig 1 - 3).
4. Remove the top outer left and right plastic covers (AT – the ‘gutter’ units at each outer side of car below windscreen). Each are held in place in with two Philips head screws and are also joined to the top inner two covers with white plastic clips. (Fig 5 - centre left) Pull slowly to remove these fragile clips, ask me how I know. Remove the inner four Philips screws holding the inner top two covers down. (Fig 3, Fig 5 LHS gutter).

6. Pull off the engine side firewall weather-stripping. (AT – don’t lose the spring clips under and inside the rubber stripping). (Fig 1 - Fig 4).
7. Just below the weather-stripping there are 4 plastic fasteners which hold the sound insulation to the firewall, the inner two have a flower shape while the outer two are flat with two little holes. All four need to be loosened, the outer two will come right off. (AT – I only found 3, 2 flower types centrally left and right and 1 flat one at right, ie, wiper motor side). (Fig 8 lwr rt).

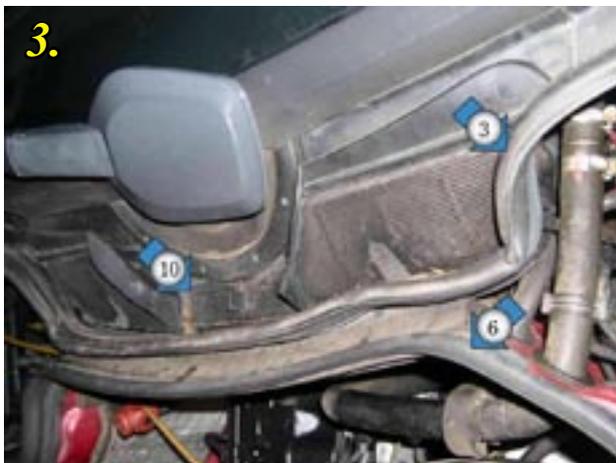
10. The center grate cover should now come straight out. (AT – This bit puzzled me at first. The central 2 vents are a SINGLE unit held by the above screws as well as by the C-shaped plastic piece on the grommet in 5 above). (Fig 3 in place; Fig 6 removed).

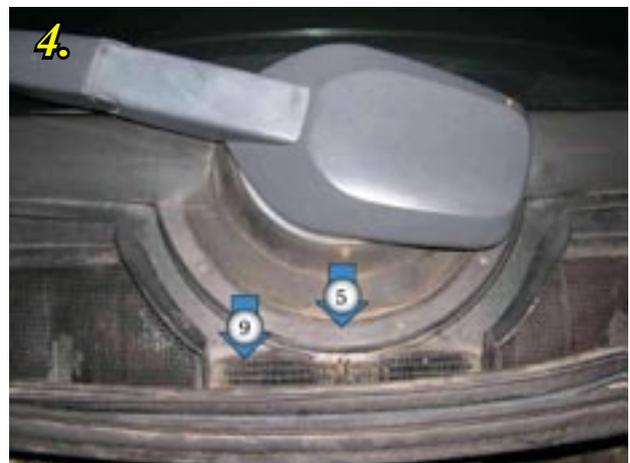
5. Remove the 4 screws holding the C shaped rubber grommet (AT – and its black plastic retaining strip over), which is below the wiper arm mechanism. (Fig 4).

9. Remove the upper left and right inner plastic covers. (AT – I think this is the single little plastic grating over the pair of drainage ducts in the centre of car). (Fig 4 lower centre).

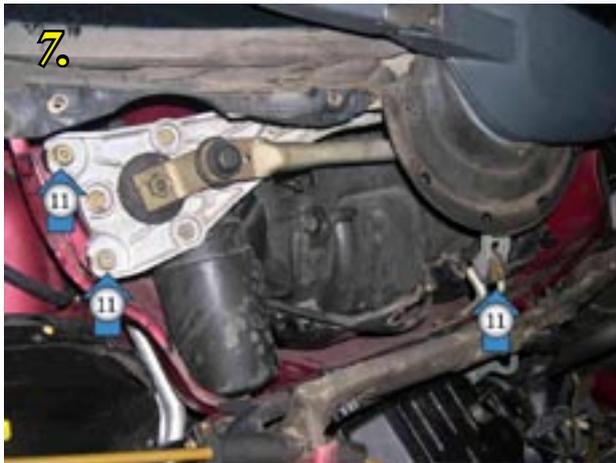
11. The wiper assembly has four 10mm nuts holding it in place, two are on the far right, and one each under the rotating center piece. Remove these nuts carefully and make sure you don't drop them like I did as they can fall into the center black hole which is not accessible. (MIA one hex screw.) I found a similar one holding the A/C pipe on the left side of the inner firewall near the fuse-box which I used to replace the lost nut. (AT – Before doing this, stuff some rags into the black holes. Note also the central brace fixing at lower centre. Also you will need to wriggle the assembly a fair bit to get it out. Take your time and it will shed the several years of grime. One warning! It's possible to dislodge the brass-coloured fixings off the ledge under the windscreen. As they say ... ask me how I know). (Fig 7 nuts on; Fig 8 nuts off).

24. Scribe the location of the crank on the motor drive axle before undoing its nut. Axle is knurled and you could be 1 or more knurls off on re-assembly. (Fig 7 - 9, Fig 20).

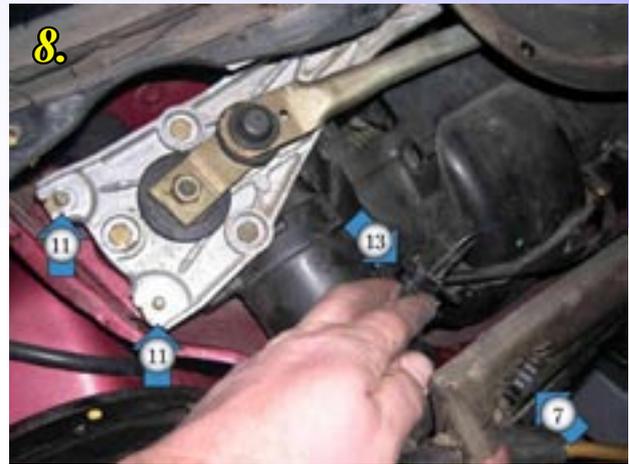
13. Remove the outside temp sensor from the blower motor cover. (Fig 8, in fingers).
14. Pry loose with fingers the blower motor harness on the left of the housing.

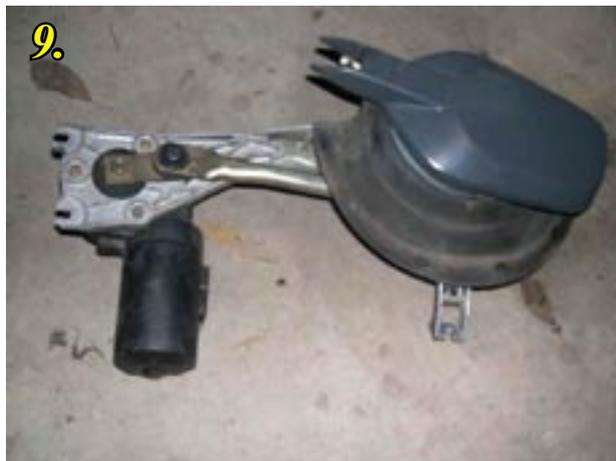
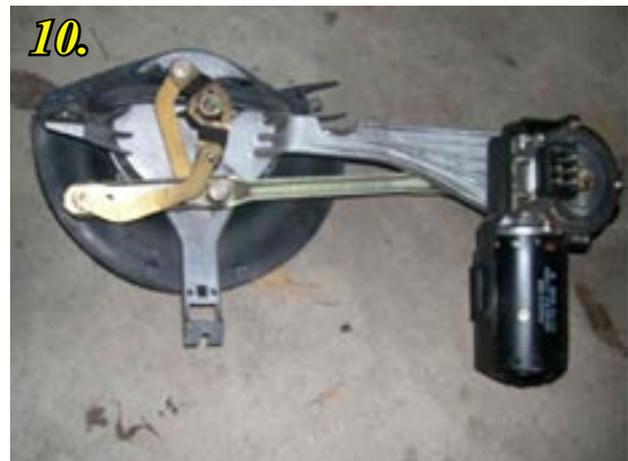
Wiper Head Disassembly and Assembly (by AT) (Fig 9 assembly front; Fig 10 assembly rear).

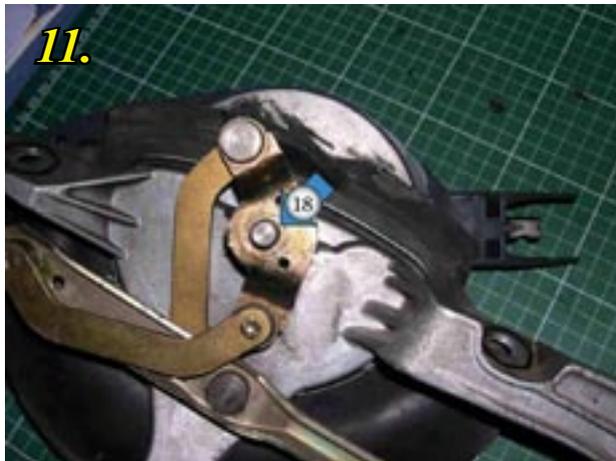
18. Refer to MB procedure 82-0760 for removal and replacement of wiper-to-motor linkage mechanism. This MUST come off to allow removal of the wiper gear head cover. Hazen Arnold thinks you should scribe the crank location on the knurled axle. I agree as there is no squared end or similar device to ensure correct orientation on replacement. (Fig 11).

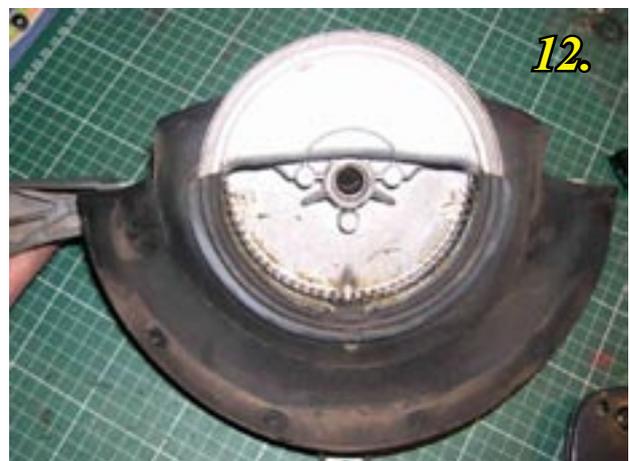
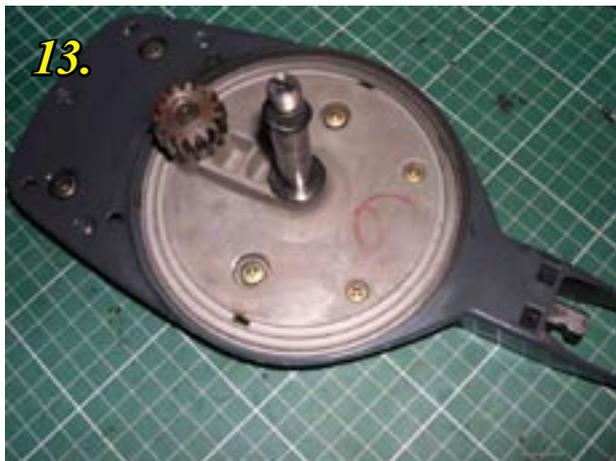
19. Refer to MB procedure 82-0765 for removal and replacement of the gear head. Note it must be in the 12 o'clock position before it can be removed. Take care of washers, C-clip and nut. (Fig 12 gear head base; Fig 13 wiper head underside).

20. The above procedure is actually for removal of the large rubber flashings (in 2 parts) from around the head assembly, but you don't HAVE to either (1) remove them to get into the gear head, or (2) replace them unless weathered or damaged. (Fig 12).

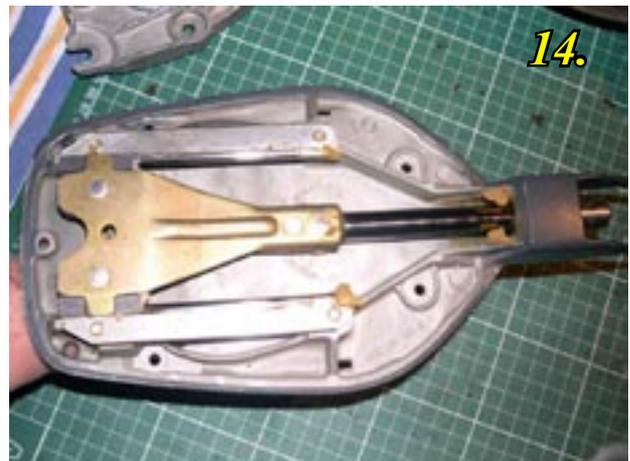
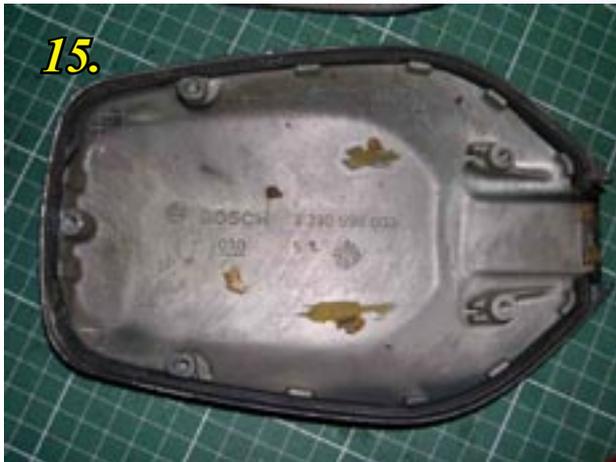
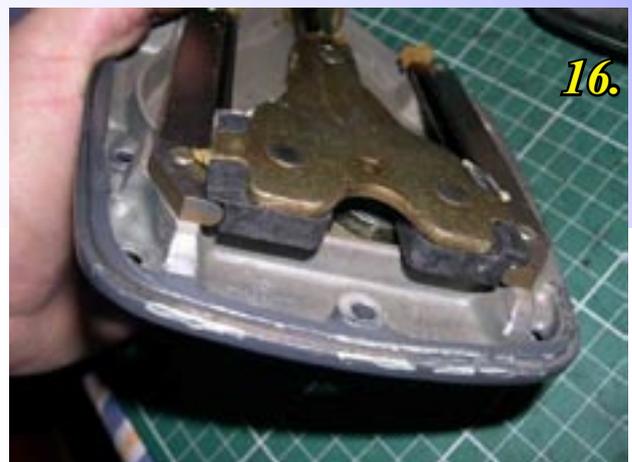
21. With gear head off, undo the FIVE small Philips head screws on the underside and carefully separate the cover from the base and slide mechanism. Take care with rubber gasket around edge. (Fig 14 - 16).

- James L Crofts has a useful photo story of this disassembly but implies there are only 3 screws holding the gear head cover. But 2 are hidden, hence item 18 above.

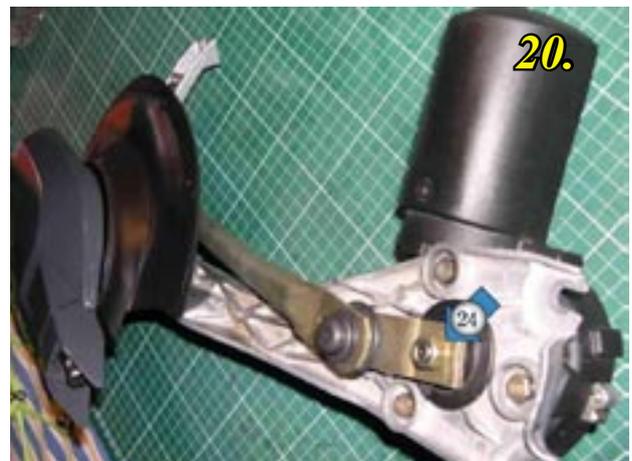
25. Remove the motor complete, undoing the 3 bolts on the alloy frame. Remove plastic cover, which just clips over the unit using the flexibility of the plastic shell. (Fig 20, cover not shown).

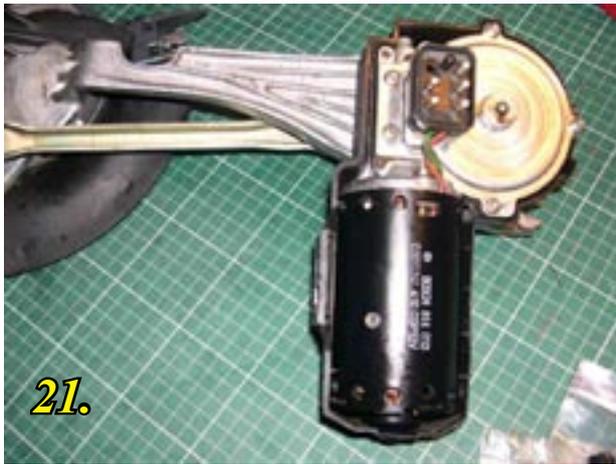
21.

27. Re-assemble in reverse order. A bit of ATF, sparingly, on the pivots of the motor-to-head mechanism is a good idea. Note the difference in ease of movement of the whole assembly. (Fig 21, Fig 22).

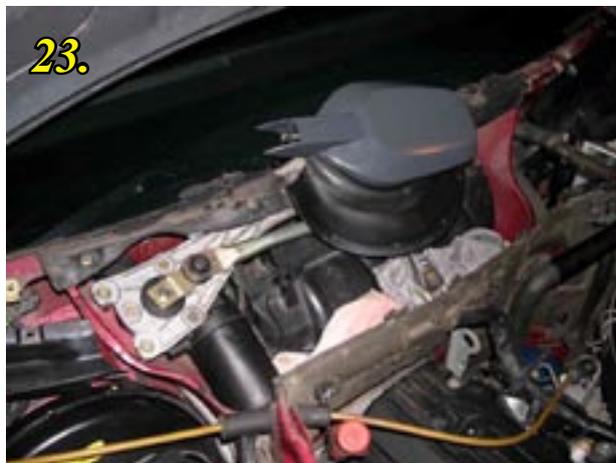
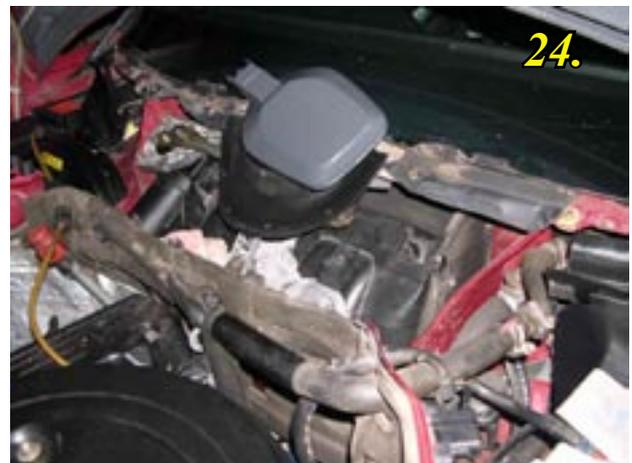
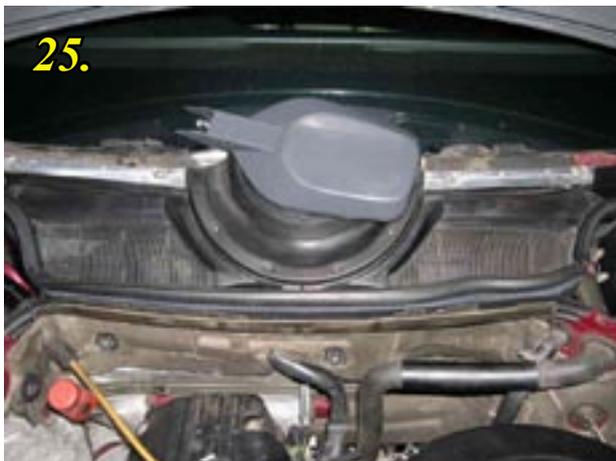
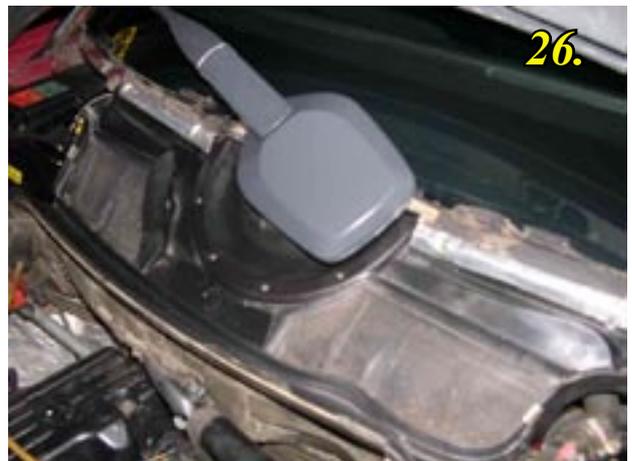
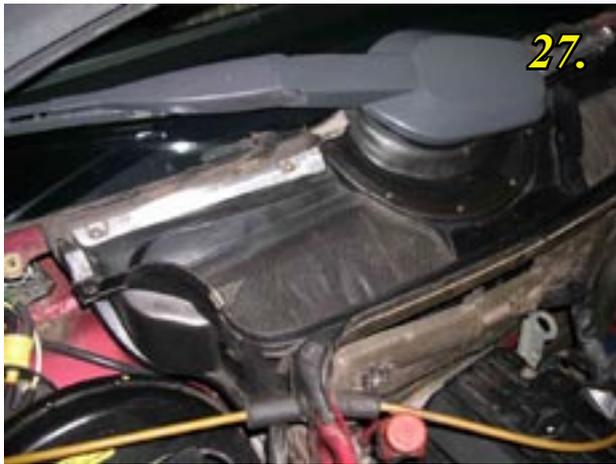
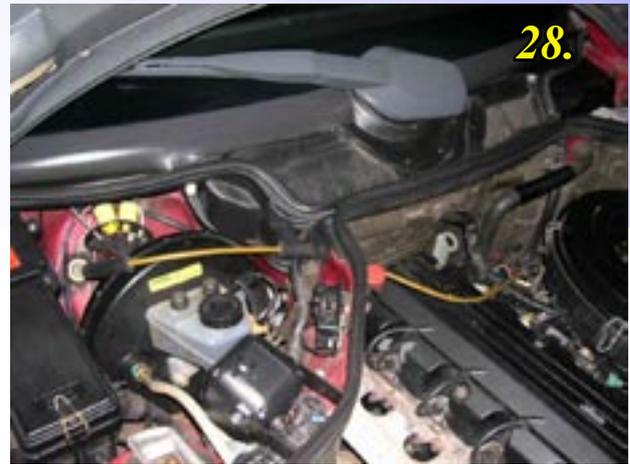
29. Before re-assembly into the car, I cleaned up all round the base of windscreen; areas hidden by the rubber stripping; inside air plenum, around battery etc.; drains at corners of windscreen; gutters up sides of windscreen. Lots of debris can accumulate all-round and this is a good opportunity to remove it.
30. When you have the wiper assembly mounted in the car operate it, (best with blade raised) to check if the coverage is correct. If not, (refer item 18) at least it's easier to take it out again at this stage if a correction to the orientation of linkage on the gear head or on the motor is required.
31. Good dose of plastic treatment, (Meguir's makes one), to all rubber and plastic parts is also called for before they go back in.

(Refer Fig 23 - Fig 30, showing clean up and re-assembly).
