40-0331 Checking camber at rear axle

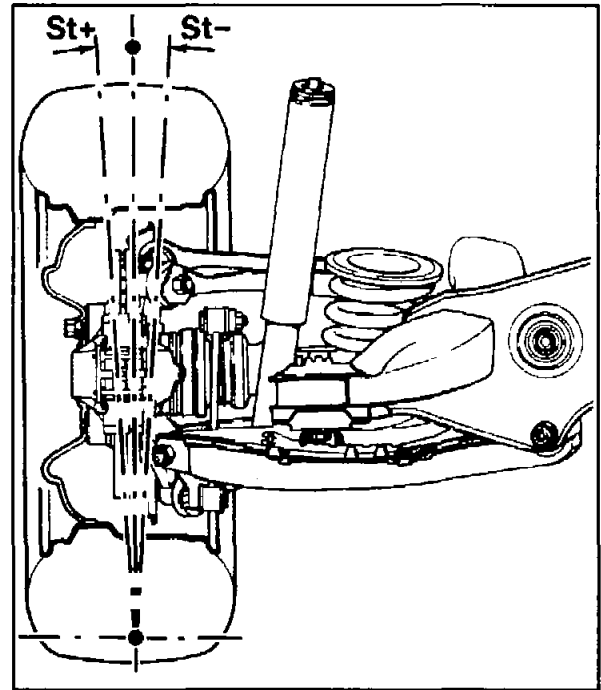
P40-5014-15

The rear axle camber results from the vehicle level whereby a corresponding rear wheel camber is assigned to a particular vehicle level (see values for wheel alignment at rear axle).

St+ = Positive camber
St- = Negative camber

Excessive deviations in the rear wheel camber can result from the following causes :

- Difference in level between left and right side of vehicle is too high.
- Camber strut bent.
- Accident damage to frame floor. Differences in level of mounting points for rear axle carrier between left and right side of body.
